# M9.0 GREAT EAST JAPAN EARTHQUAKE & TSUNAMI

## March 11, 2011

MRP Engineering Summary Report

August 2011

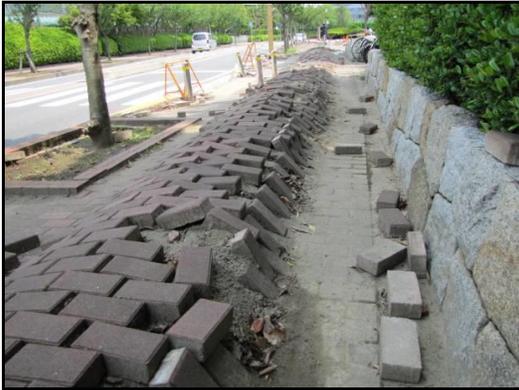
*Chiba (Tokyo metro): Areas built on reclaimed land along Tokyo Bay experienced soil liquefaction which induced buoyant forces on a pipeline beneath this sidewalk.*

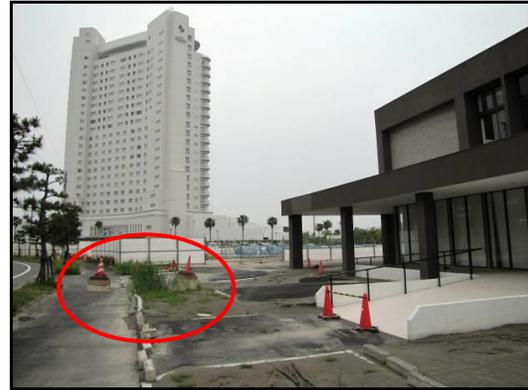
*Urayasu (Tokyo area): The community was developed on reclaimed landfill along Tokyo Bay and experienced extensive soil liquefaction (see uplifted manholes). The hotel in the background was developed on a seismically improved (densified) site which performed well during the earthquake.*

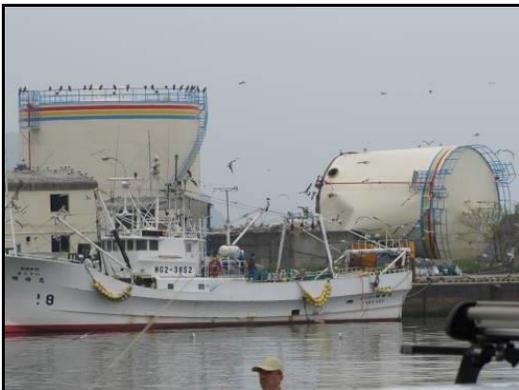
*Ishinomaki (Miyagi): Damaged tanks at Port of Ishinomaki. Displaced or overturned steel tanks were a common occurrence in tsunami inundated areas.*

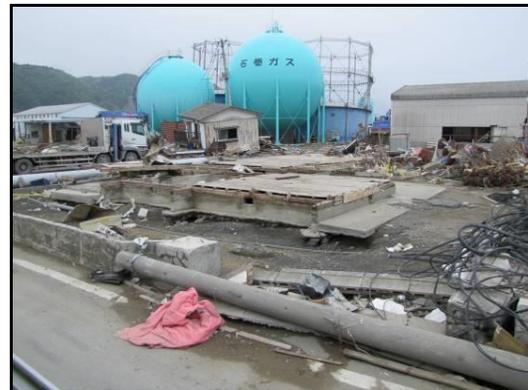
*Ishinomaki (Miyagi): Tsunami erosion and damage around gas storage facility near the waterfront. Wood-framed structures (foreground) were wiped out by the tsunami forces.*

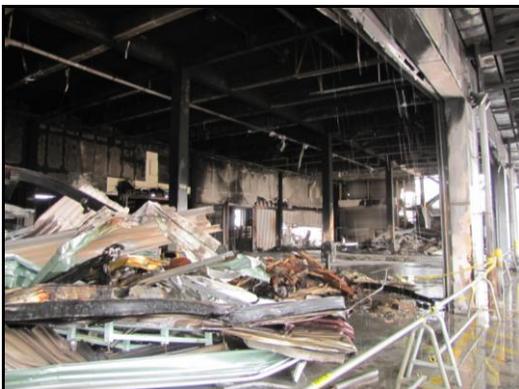
*Sendai Airport (Miyagi): A cargo warehouse was damaged by fire that initiated from a vehicle (battery) displaced by the tsunami.*

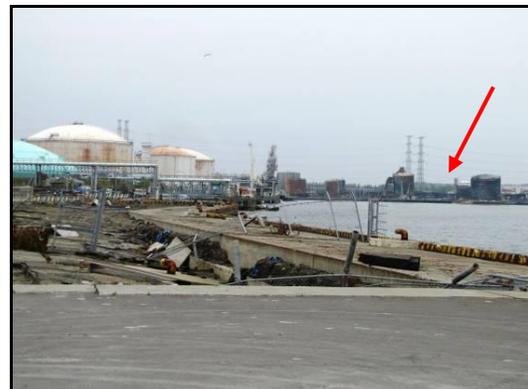
*Port of Sendai: Tsunami erosion behind a ship berth and a fuel storage facility (background) damaged by fire.*

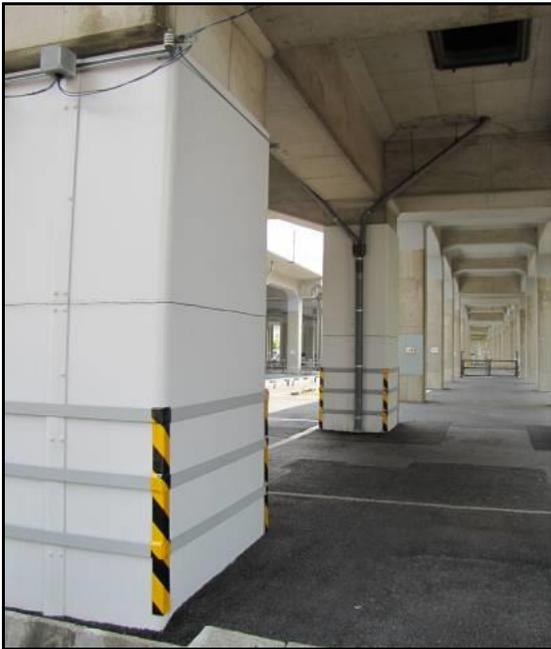
- Following the 1995 Kobe earthquake, the country embarked on a seismic retrofit program for bridges as well as elevated roadways and rail viaducts (see photo below). Much of this program was completed by 2011.

*Tokyo: Seismic retrofits of elevated railways and highways (column steel jackets) were a common sight in the region.*

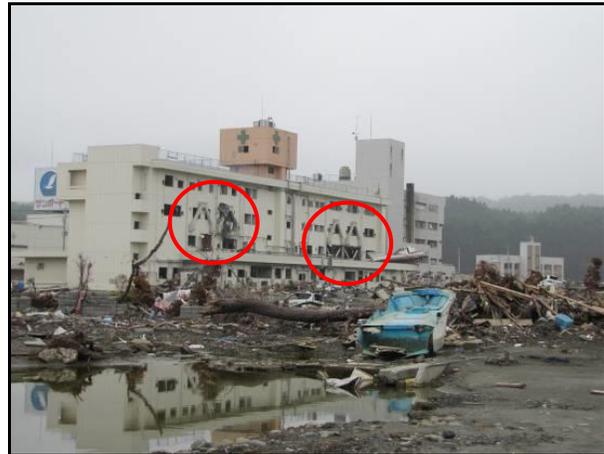
- Along the Miyagi coast many hospital and school buildings (see photo below) were also seismically retrofitted. The upgraded structures survived the strong shaking and provided vertical evacuation shelters during the ensuing tsunamis.

*Minamisanriku (Miyagi): The seismically retrofitted hospital (with external inverted "V" braced frames) survived three minutes of strong ground shaking, followed by a tsunami that reached the upper level. The four-story structure was barely tall enough to serve as tsunami vertical evacuation shelter.*
