M8.8 MAULE EARTHQUAKE

February 27, 2010

MRP Engineering Summary Report

March 2011

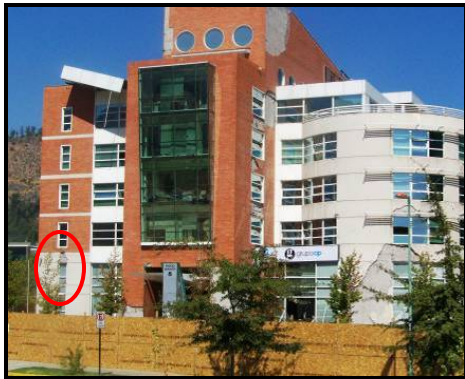
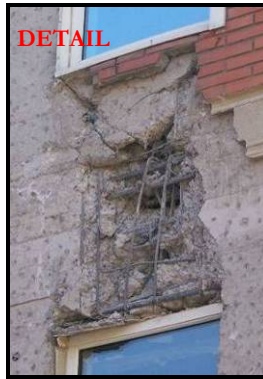
Example of extensive structural damage at Ciudad Empresarial (Santiago area). This recent vintage five-story office building suffered extensive damage (see detail). Irregular layout and weak soils contributed to the damage.

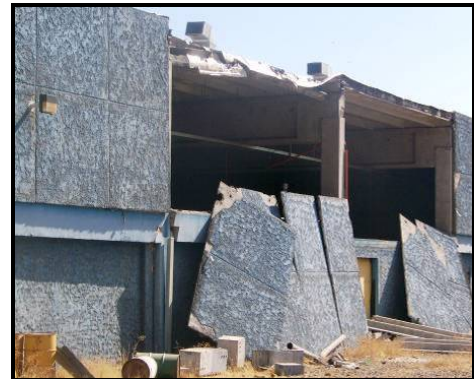
Precast reinforced concrete construction at Ciudad Empresarial. Inadequate wall panel connections resulted in building damage.

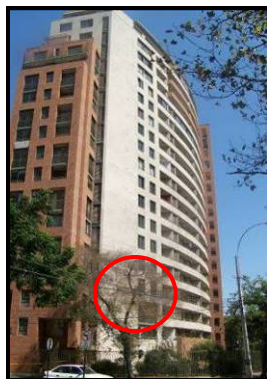
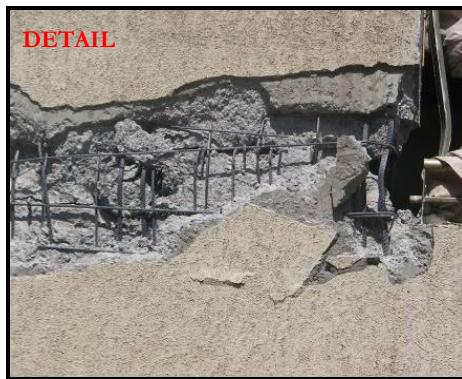
Modern high-rise residential tower in Santiago with extensive reinforced shear wall damage, as shown on the close-up photo. This building could not be occupied for months.

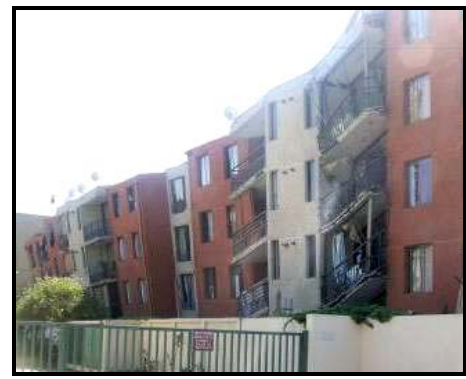
Collapsed reinforced concrete apartment building in Maipú area (Santiago). The structure featured tuck-under (open) parking at base.

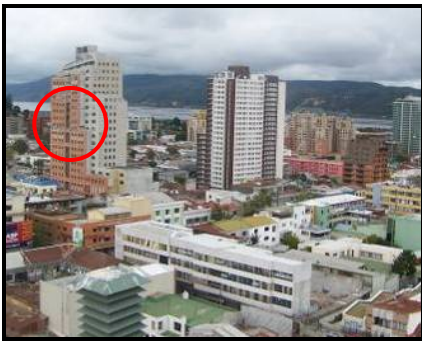
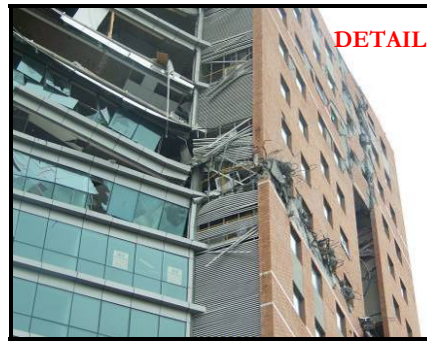
A number of high-rise buildings in Concepción suffered extensive structural damage as shown in the close-up photo on right.

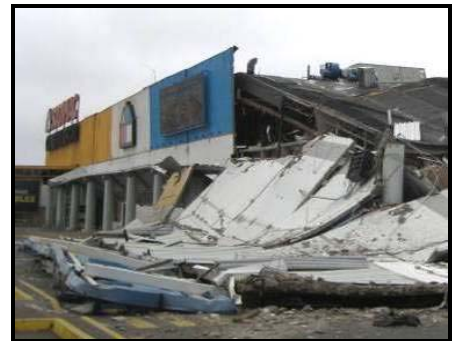
Collapsed concrete tilt-up wall panels due to weak wall-to-roof connections.

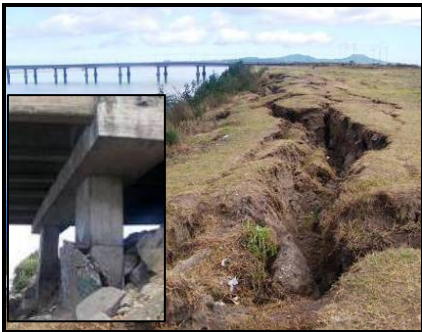
Juan Pablo II (Concepción) bridge damage and riverbank lateral spreading.

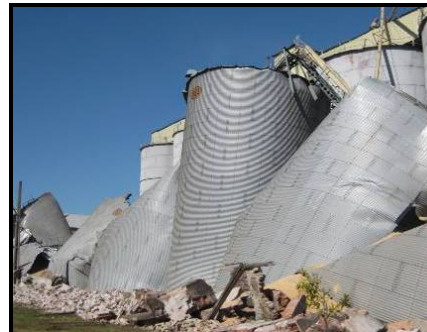
Collapsed thin-walled steel grain tanks.

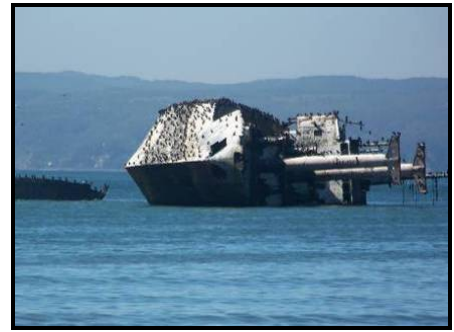
Example of tsunami effects on the Talcahuano fishing fleet.

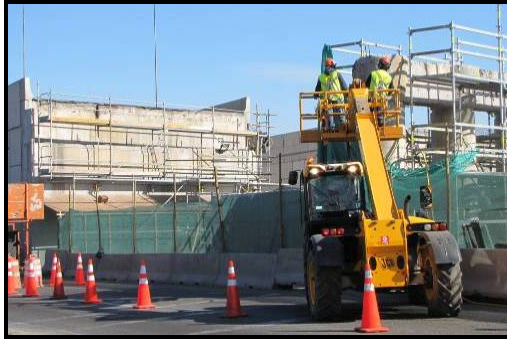
Collapsed bridge repairs (Vespucio Norte Highway)

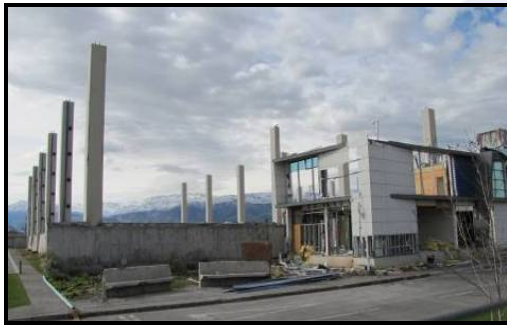
Destroyed modern industrial facility (Lampa)

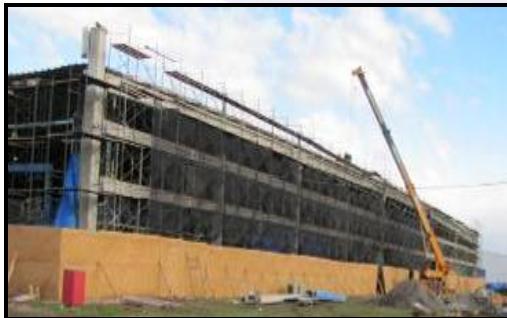
Repairs at a production plant (Lampa)

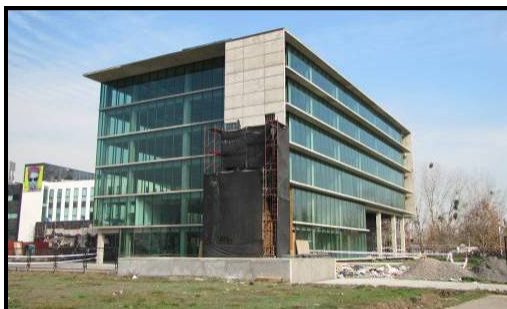
Office building repairs (Ciudad Empresarial)

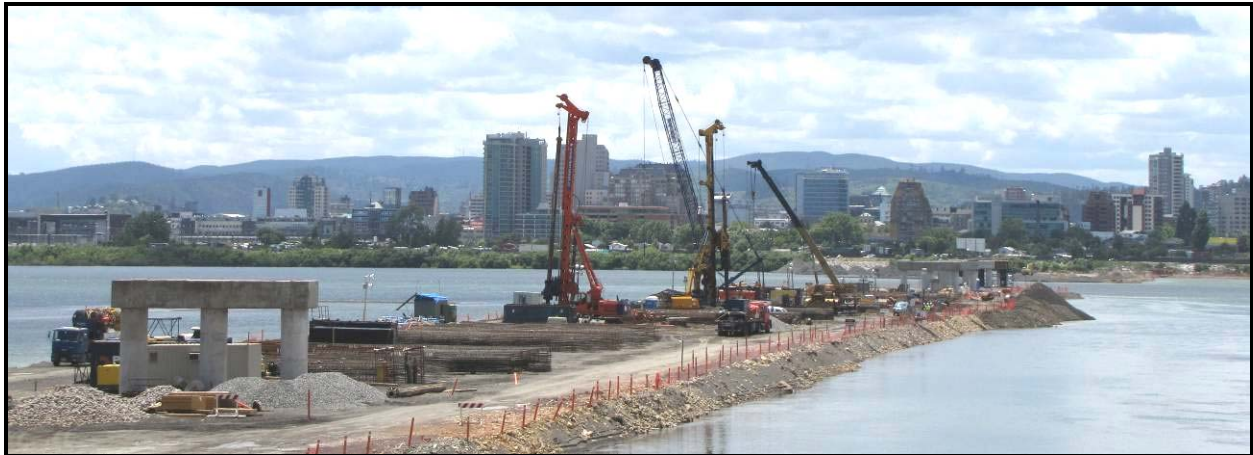
December 2010: Construction is in progress on a new highway bridge over the Bío Bío River in Concepción. This crossing will replace a bridge damaged by the earthquake. The city skyline (background) includes a number of vacant residential towers.

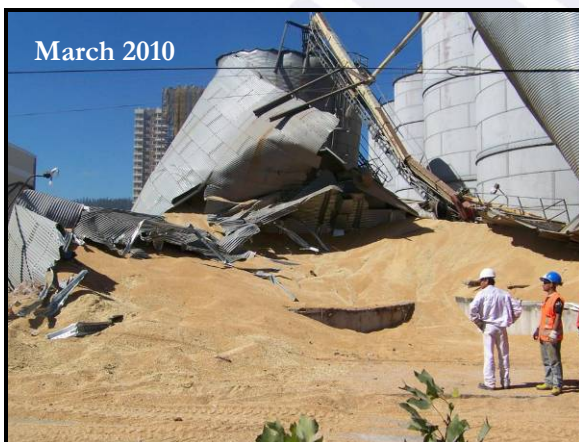
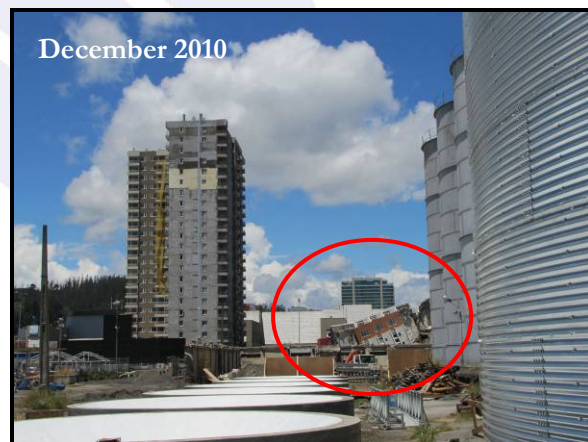
Concepción City Center: Collapsed grain bins have been removed but not yet replaced as shown in these two images taken in March and December of 2010. The 20-story residential tower in the background remains vacant. The right photograph includes the toppled Rio Alto tower (circled) which is still under investigation.

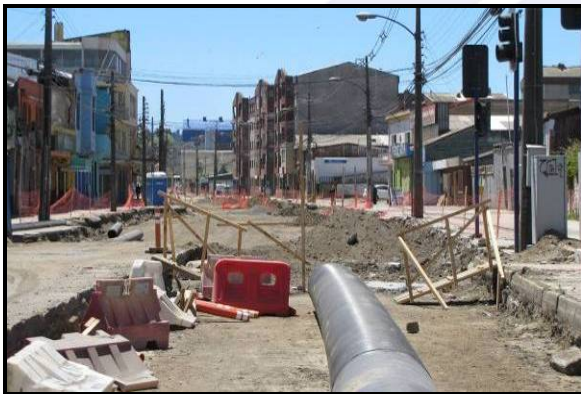
Street and utility reconstruction in Talcahuano city center is evident throughout the low-lying areas of this community.

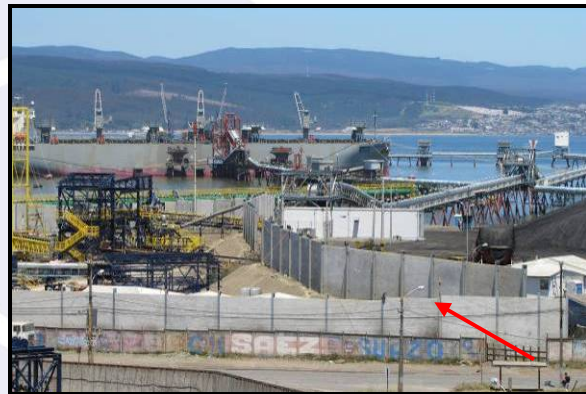
Tsunami-prone areas of Port of Coronel (south of Concepción) are surrounded by new flood walls.

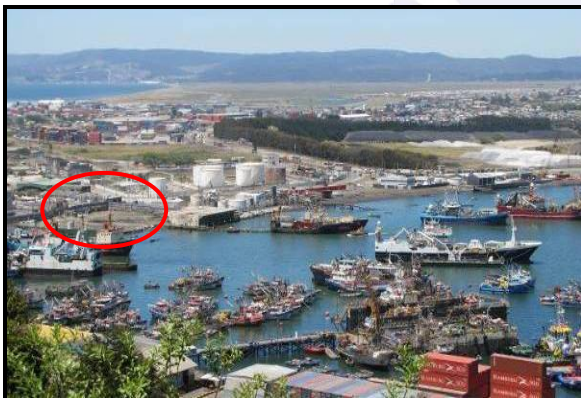
San Vicente Bay's industrial zone is recovering. A fish-processing plant (circled) has been demolished. Beach area was contaminated due to broken petroleum lines.

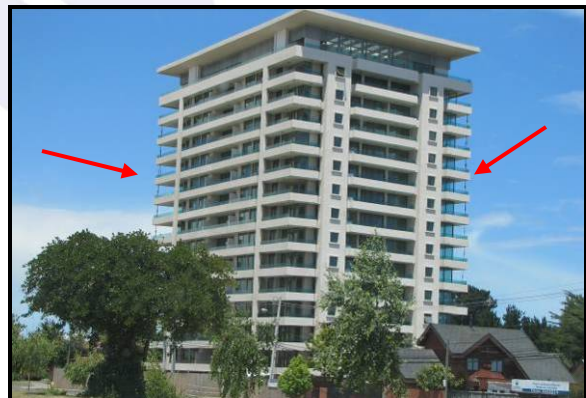
Damaged condominium tower in San Pedro still stands vacant. Corner balconies remain shored up.

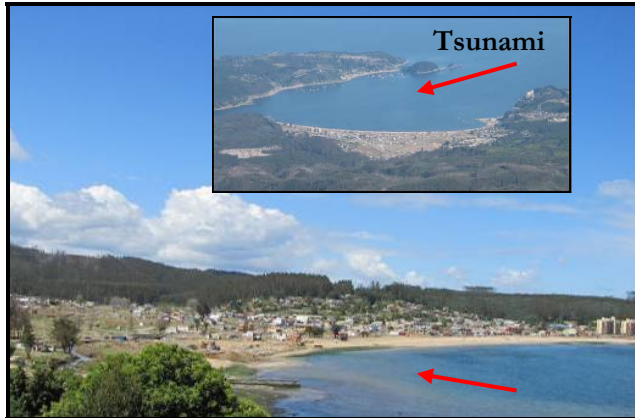
Panoramic view of the Dichato waterfront community devastated by the tsunamis that followed the earthquake

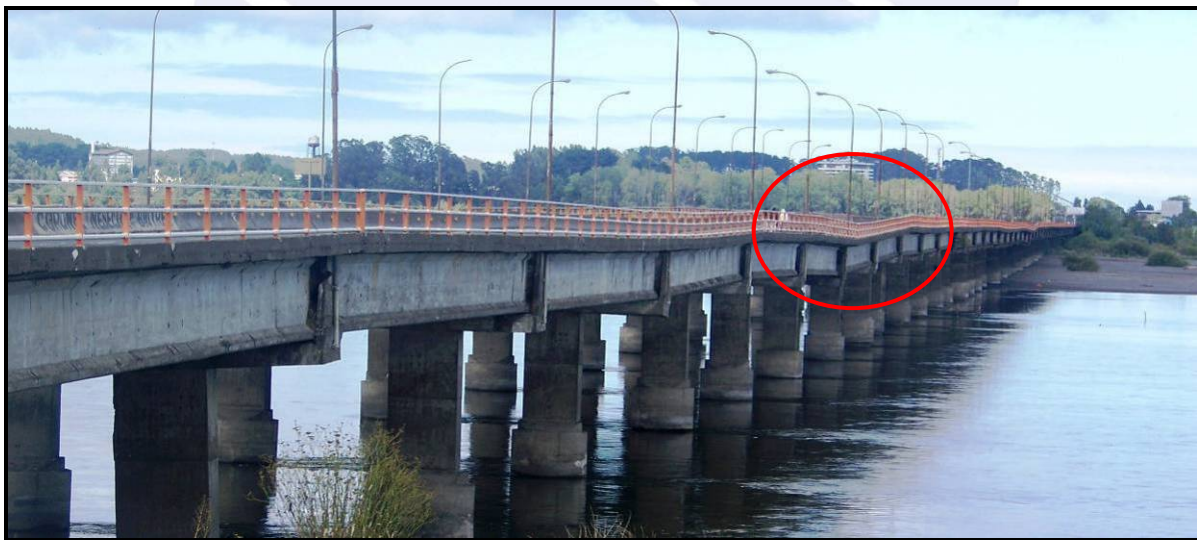
Juan Pablo II Bridge damaged in the February earthquake was restored to service in October 2010. This photo from March 2010 illustrates some of the bridge foundation damage as evidenced by the sagging roadway.

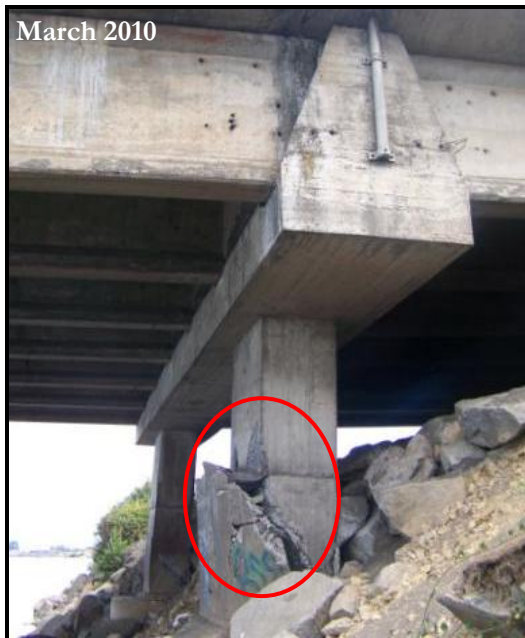
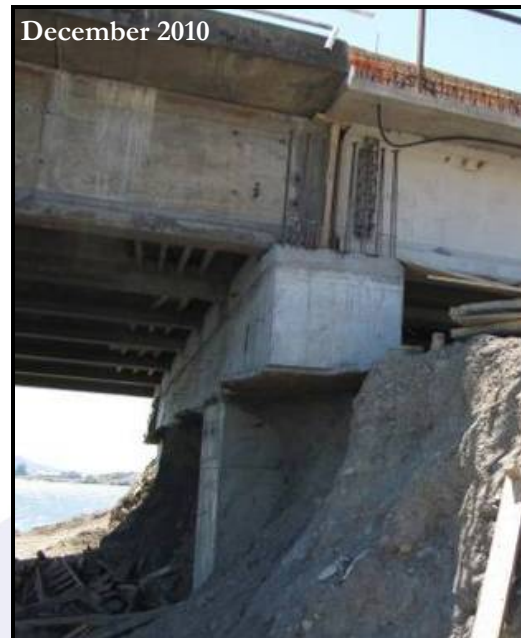
The photo on the left shows Juan Pablo II Bridge fractured column caused by soil liquefaction and lateral spreading along the the Bío Bío riverbank. The photo on the right depicts the new bridge girder and columns.
