MEXICO CITY RECOVERY UPDATE: SEVEN MONTHS AFTER THE M7.1 CENTRAL MEXICO EARTHQUAKE

MRP Engineering Newsletter

July 2018

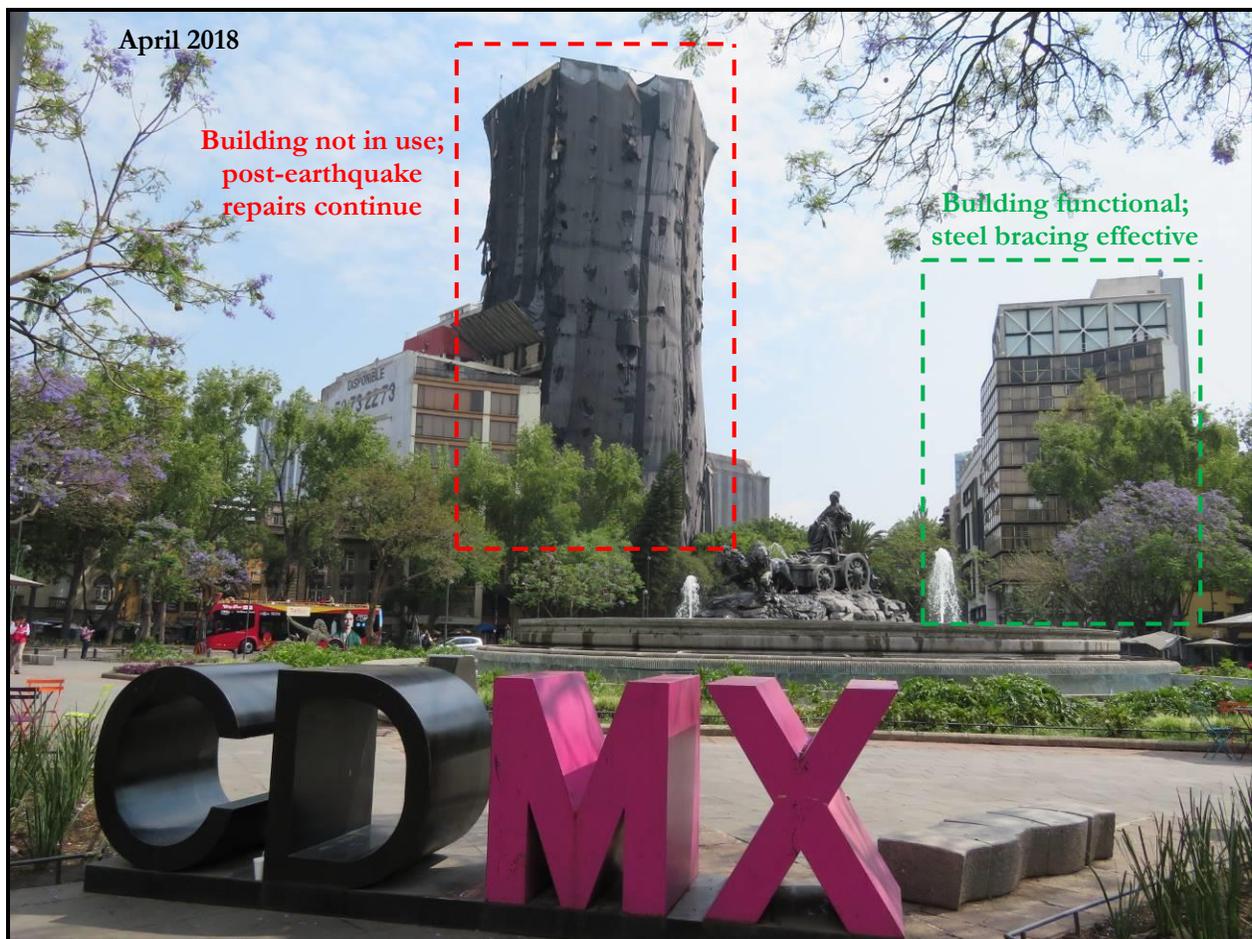
Mexico City Plaza Villa Madrid—The two structures in the background illustrate post-earthquake status quo. The shrouded high-rise structure (left) is still undergoing lengthy repairs. The building on the right with steel braced frames is fully functional.

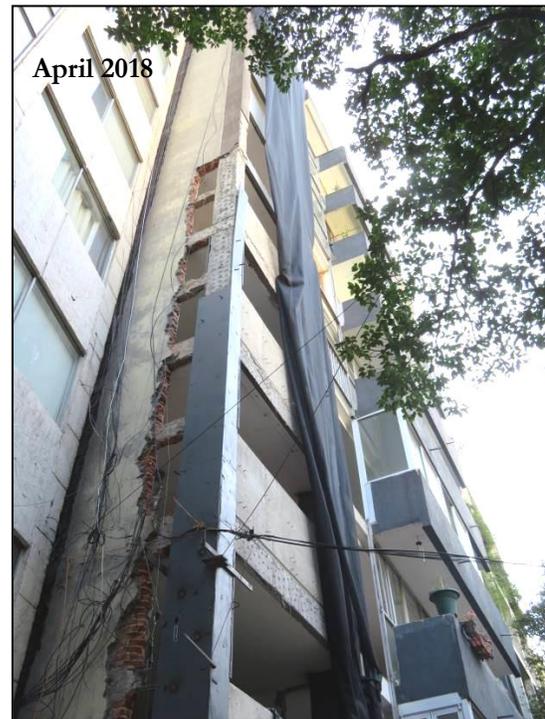
Example reinforced concrete frame apartment building in La Condesa undergoing post-earthquake repairs and retrofit with new steel plates over existing concrete columns.

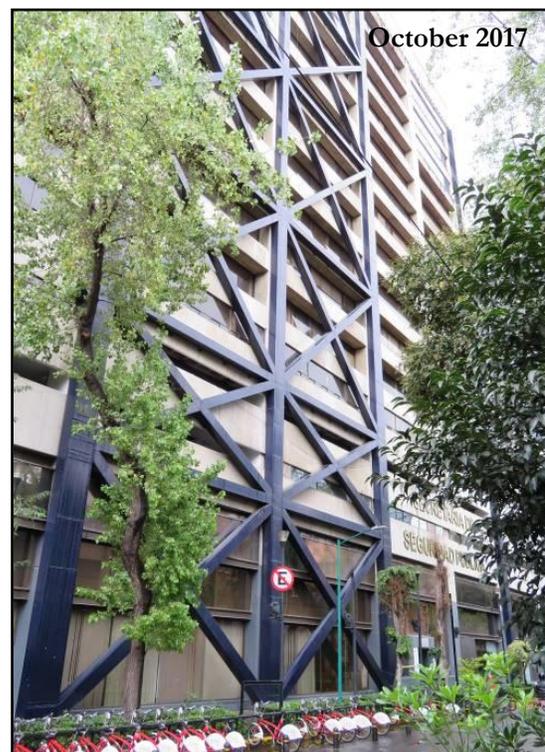
Example of a seismic upgrade of an existing reinforced concrete frame building with steel braced frames.

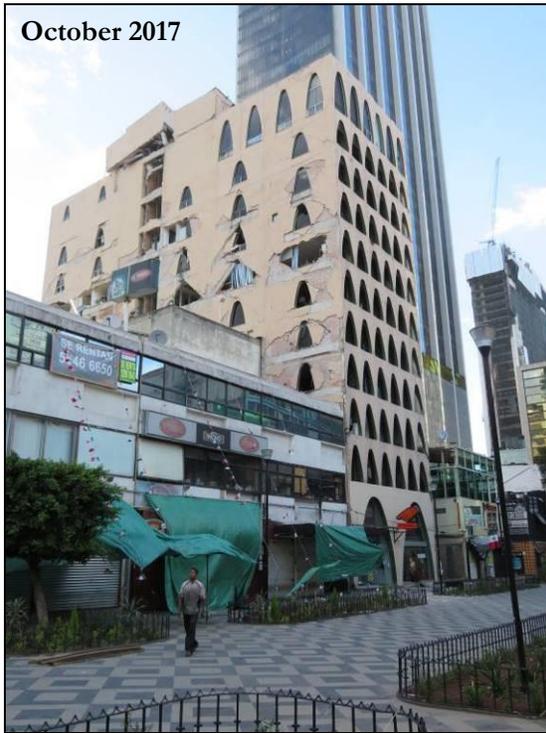
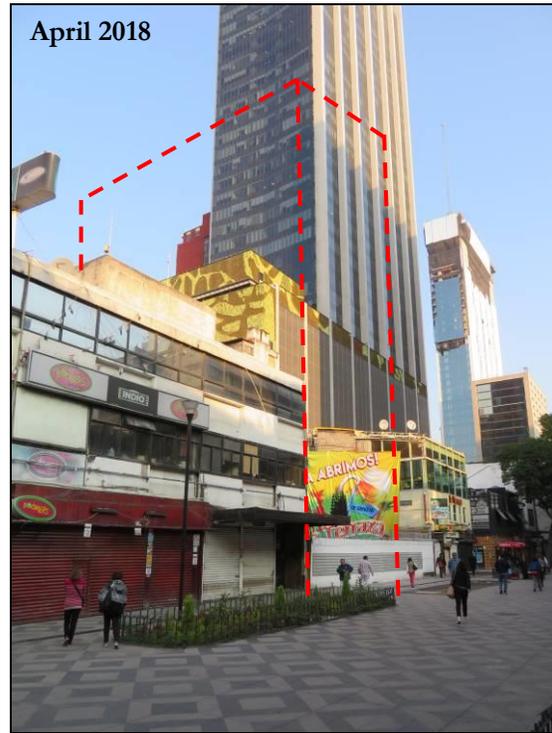
This damaged 12-story building with reinforced concrete bracing was demolished. Adjacent restaurants and businesses were impacted by street closures and demolition activities.

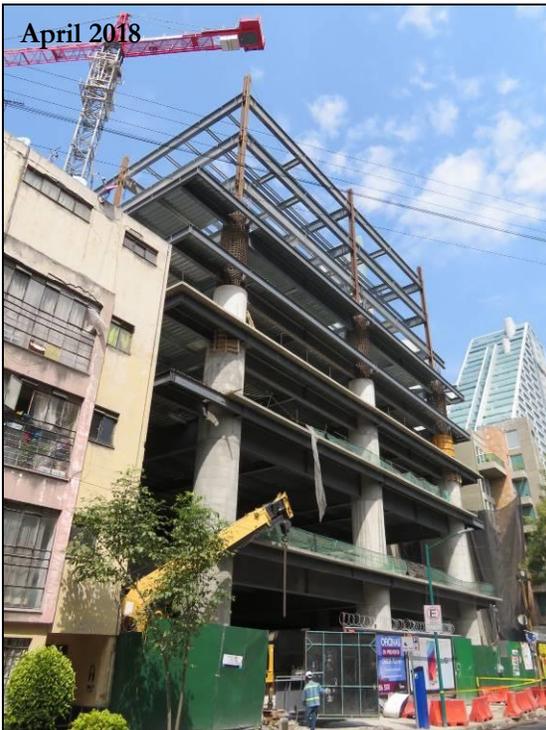
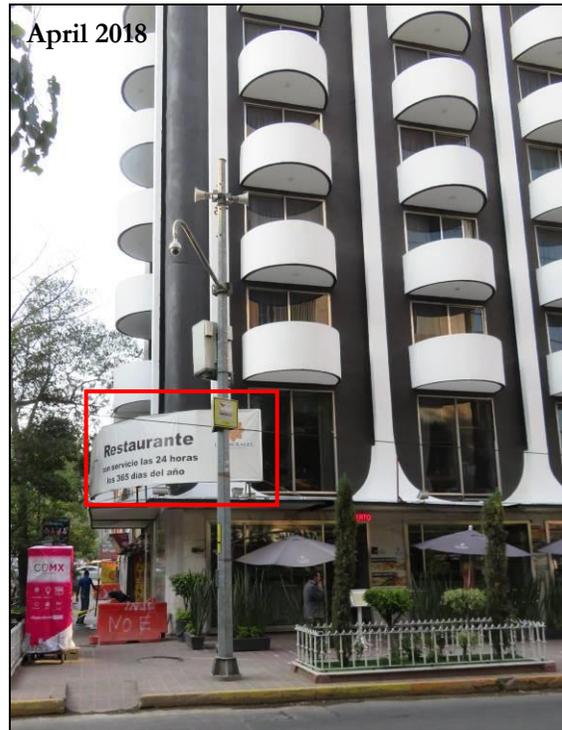
Example new construction infilling a vacated lot. New framing includes heavily reinforced concrete columns.

Restaurants and other businesses adjacent to damaged buildings advertise as “always open (24/365) for business”.

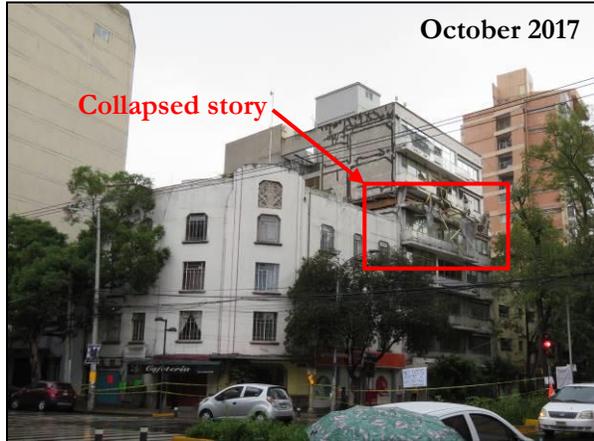
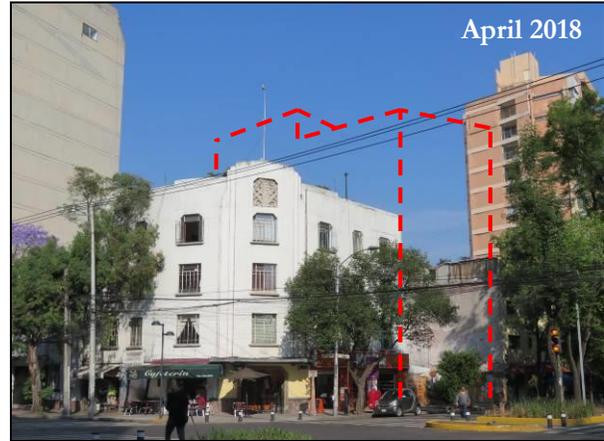
Example of a pre-1985 reinforced concrete frame building failure. Typical issues included: impact with adjacent structures, inadequate reinforcement of concrete members, and twisting of irregularly shaped structures.

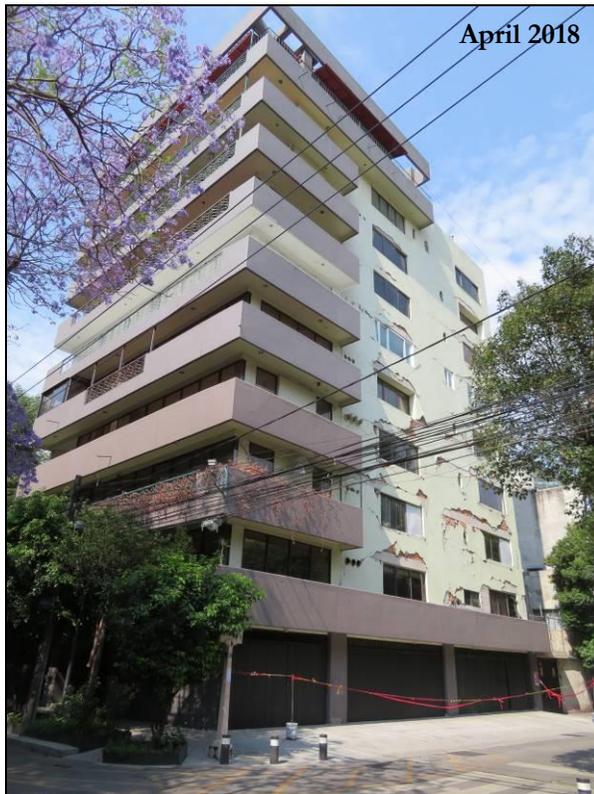
Vacant damaged apartment building in La Condesa. Note concrete frame and brick infill wall construction with extensive ground-level openings.

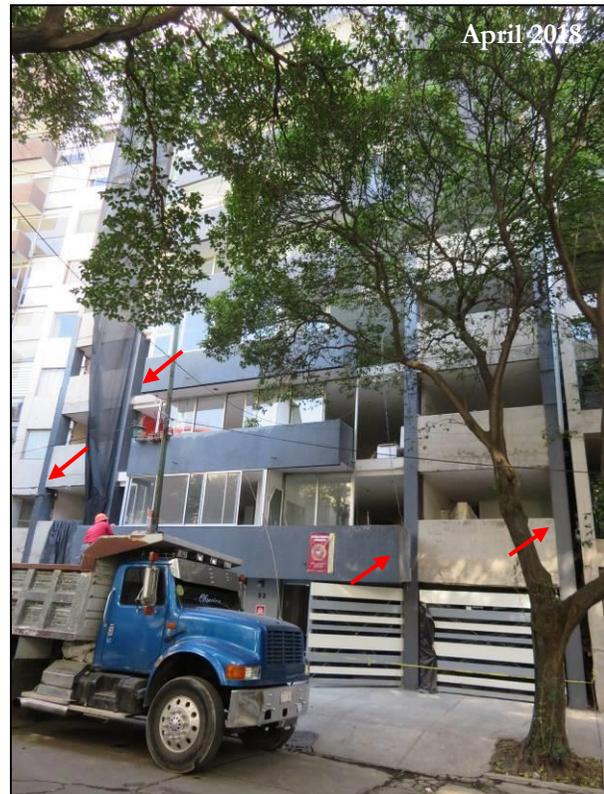
An apartment building undergoing damage repairs and column upgrades (steel plate jackets).

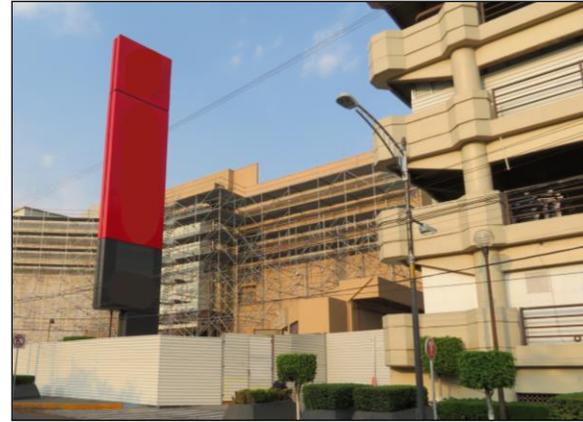
Earthquake damage repairs still in progress at the Coapa regional shopping mall.

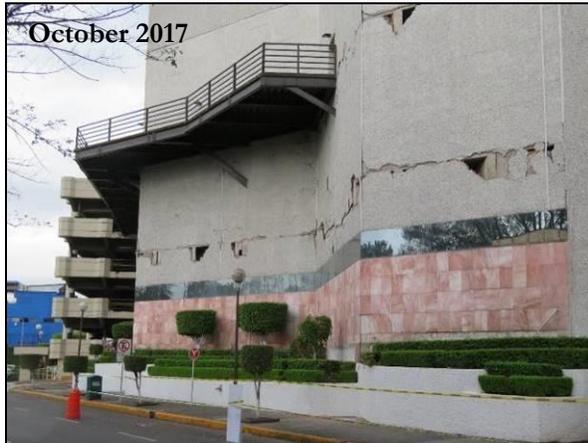
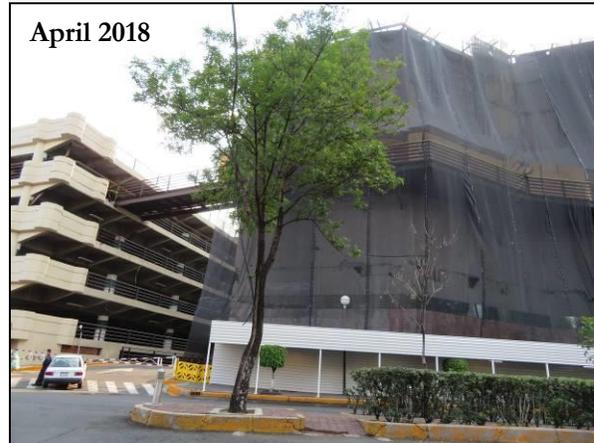
A regional mall in Coapa experienced extensive damage to pedestrian bridges, nonstructural systems, and façades. The complex is currently undergoing an extensive and lengthy renovation as a result of earthquake damage.

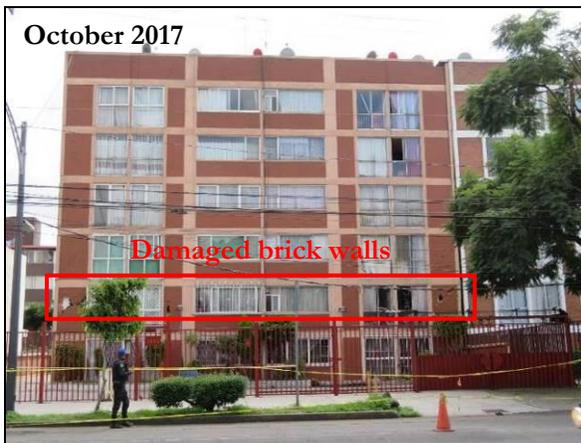
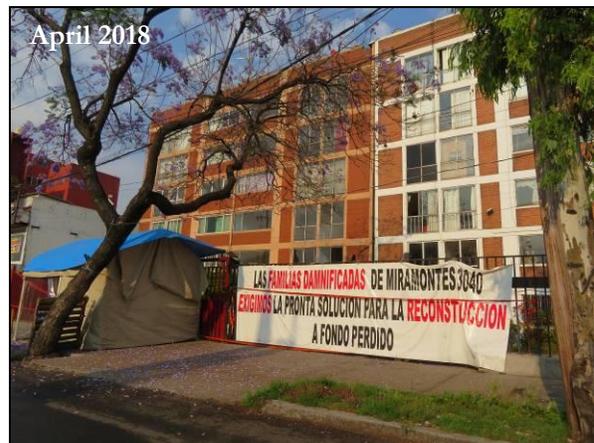
Coapa multi-family residential structures commonly include concrete framing with lightly reinforced masonry walls. Damage to walls and adjacent concrete framing was commonly observed. Many such damaged structures still remain vacant resulting in prolonged hardships for the displaced families.

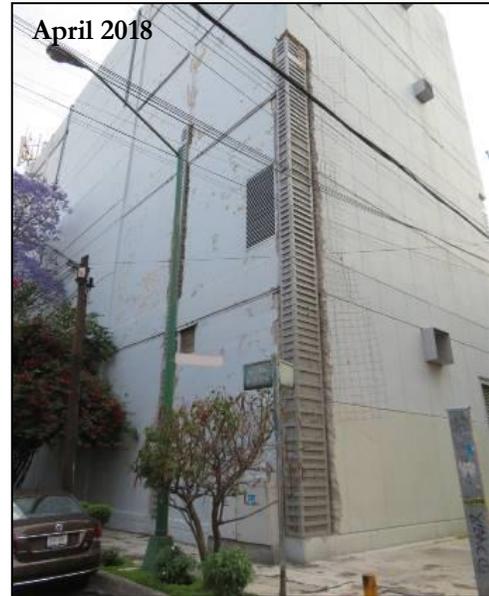
Critical facilities: Earthquake repairs and upgrades (column strengthening) continue at a telecom central office in Coapa.

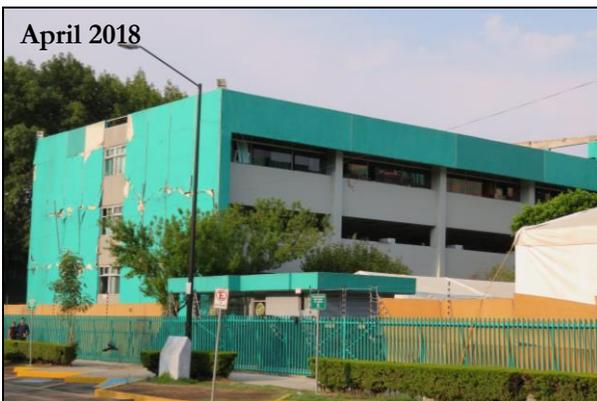
Schools: A damaged classroom building still stands vacant at a private college in Coapa.

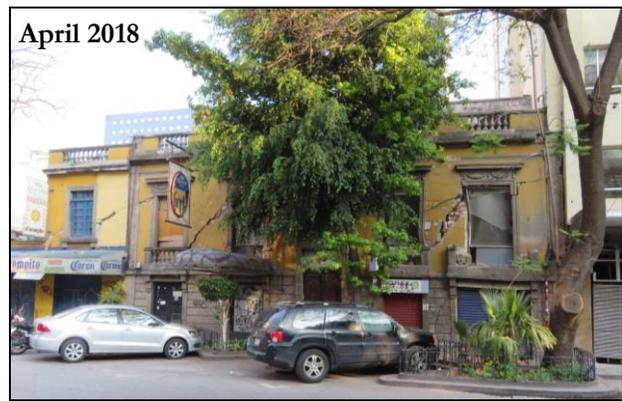
Vulnerable structures: A damaged unreinforced masonry (URM) building (adjacent to a high-rise apartment building) remains unattended.
