M8.8 MAULE EARTHQUAKE

February 27, 2010

MRP Engineering Summary Report

March 2011

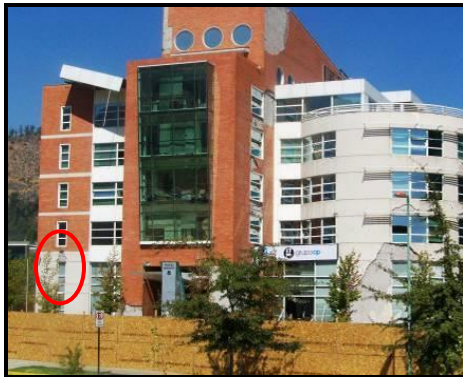
Example of extensive structural damage at Ciudad Empresarial (Santiago area). This recent vintage five-story office building suffered extensive damage (see detail). Irregular layout and weak soils contributed to the damage.

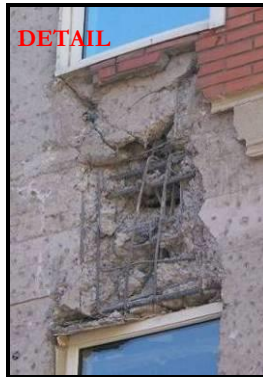
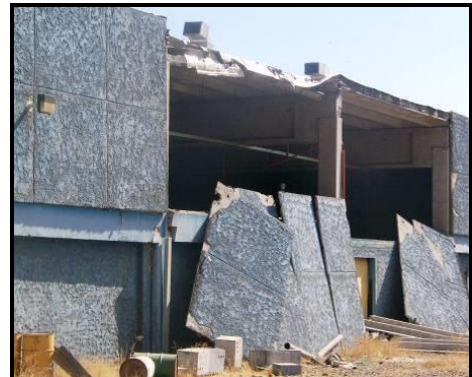
Precast reinforced concrete construction at Ciudad Empresarial. Inadequate wall panel connections resulted in building damage.

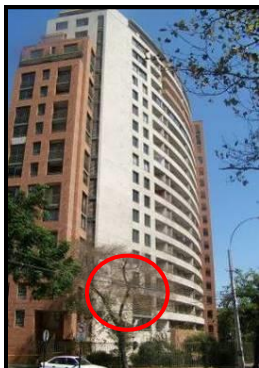
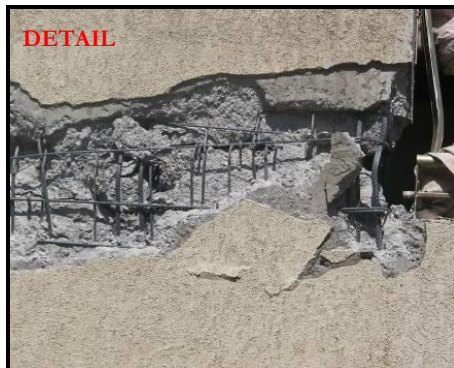
Modern high-rise residential tower in Santiago with extensive reinforced shear wall damage, as shown on the close-up photo. This building could not be occupied for months.

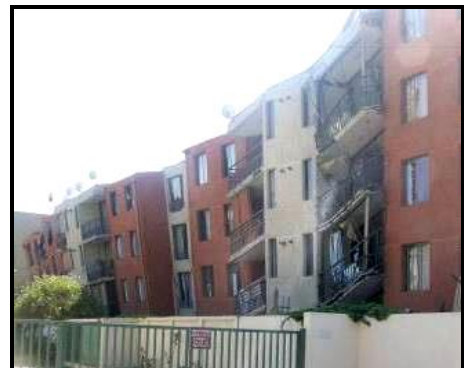
Collapsed reinforced concrete apartment building in Maipú area (Santiago). The structure featured tuck-under (open) parking at base.

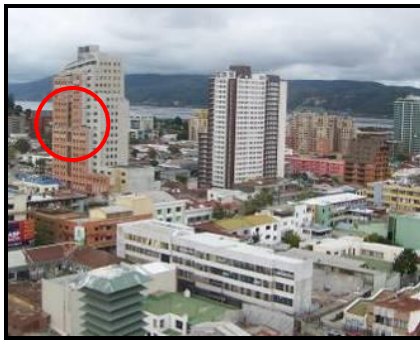
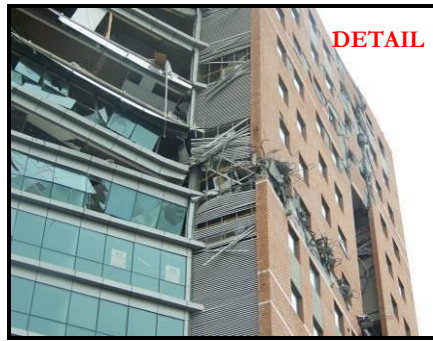
A number of high-rise buildings in Concepción suffered extensive structural damage as shown in the close-up photo on right.

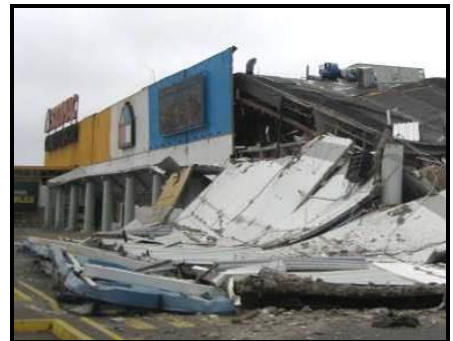
Collapsed concrete tilt-up wall panels due to weak wall-to-roof connections.

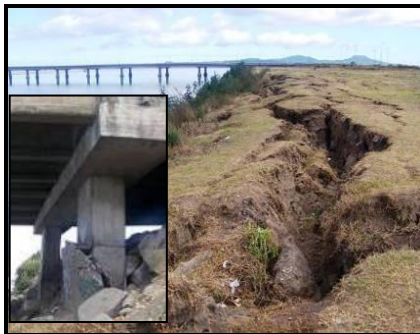
Juan Pablo II (Concepción) bridge damage and riverbank lateral spreading.

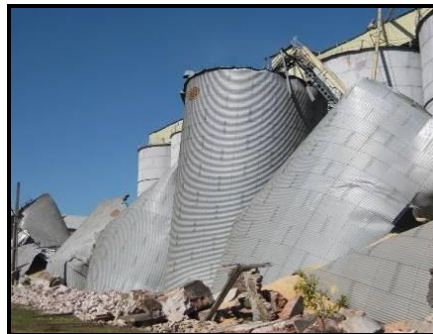
Collapsed thin-walled steel grain tanks.

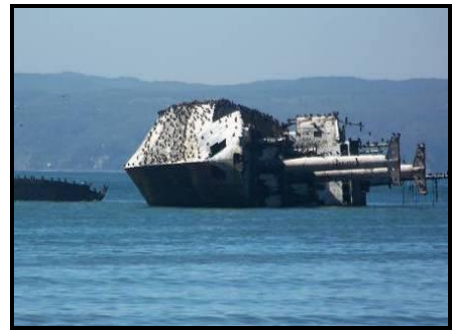
Example of tsunami effects on the Talcahuano fishing fleet.

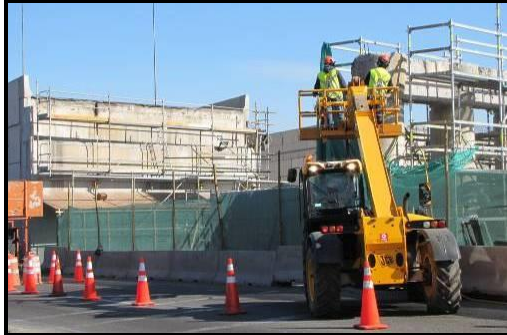
Collapsed bridge repairs (Vespucio Norte Highway)

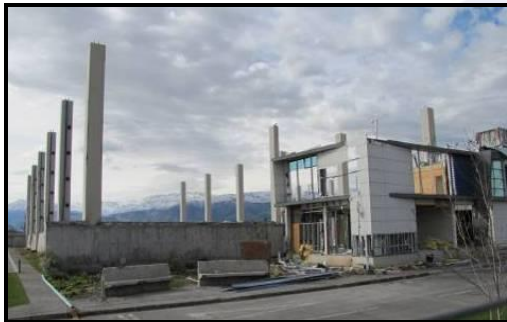
Destroyed modern industrial facility (Lampa)

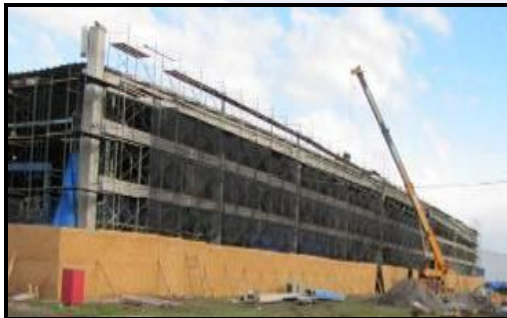
Repairs at a production plant (Lampa)

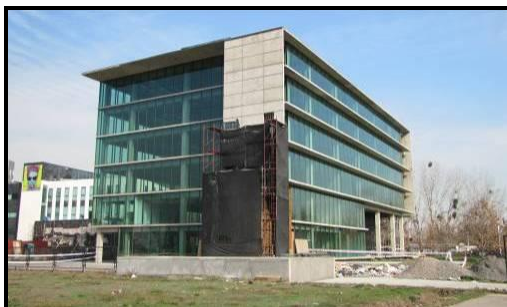
Office building repairs (Ciudad Empresarial)

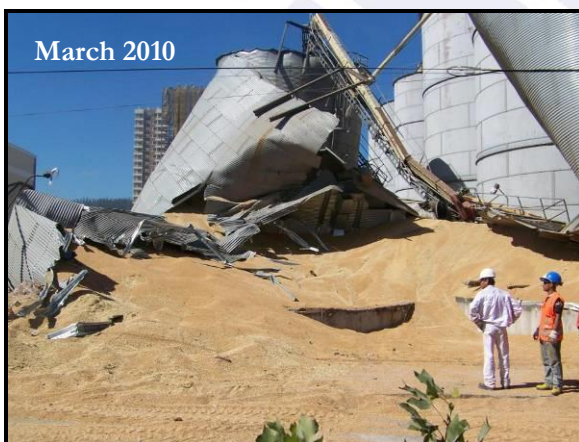
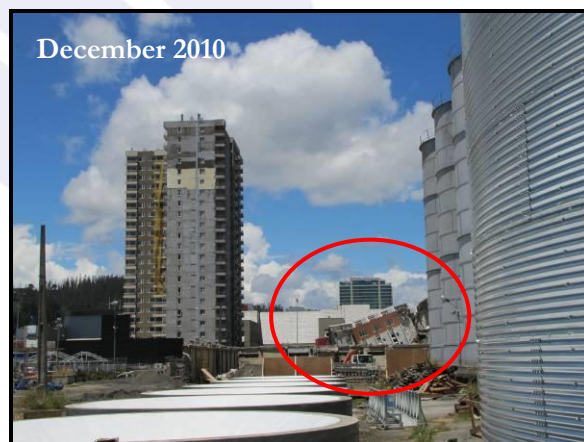
Concepción City Center: Collapsed grain bins have been removed but not yet replaced as shown in these two images taken in March and December of 2010. The 20-story residential tower in the background remains vacant. The right photograph includes the toppled Rio Alto tower (circled) which is still under investigation.

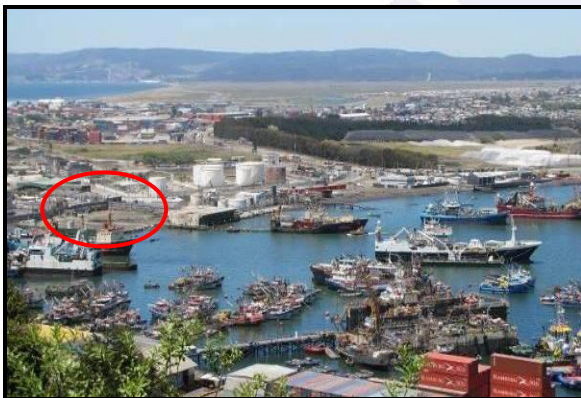
San Vicente Bay's industrial zone is recovering. A fish-processing plant (circled) has been demolished. Beach area was contaminated due to broken petroleum lines.

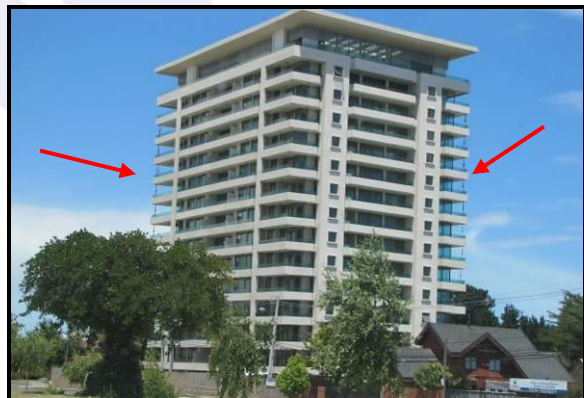
Damaged condominium tower in San Pedro still stands vacant. Corner balconies remain shored up.

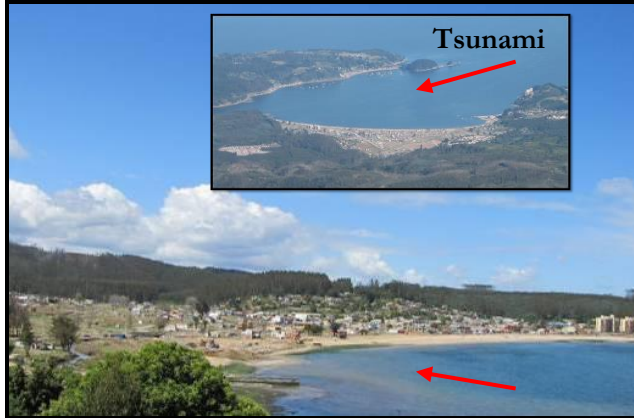
Panoramic view of the Dichato waterfront community devastated by the tsunamis that followed the earthquake

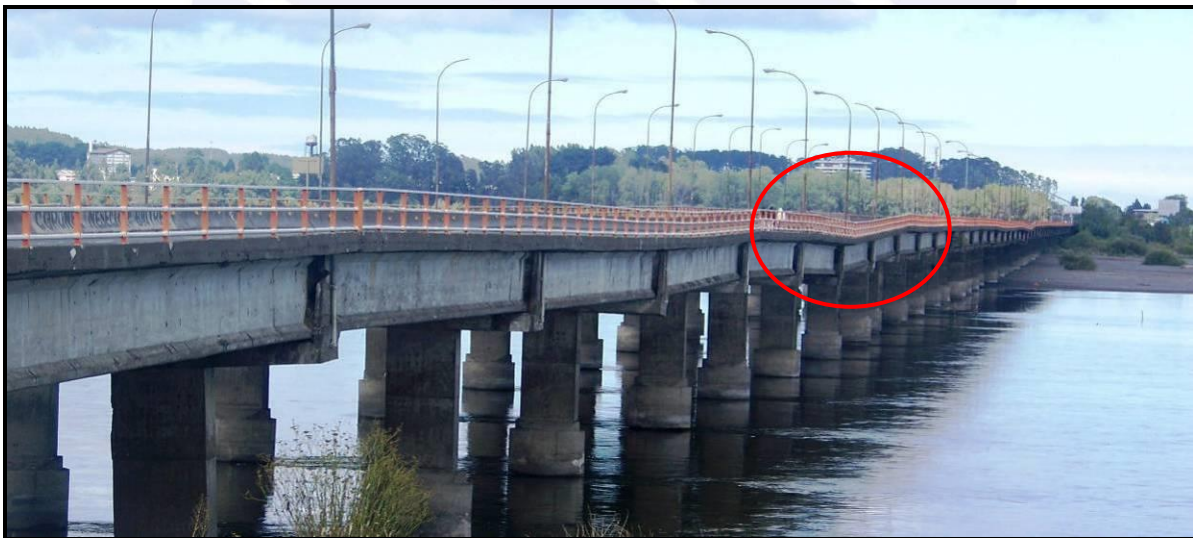
Juan Pablo II Bridge damaged in the February earthquake was restored to service in October 2010. This photo from March 2010 illustrates some of the bridge foundation damage as evidenced by the sagging roadway.

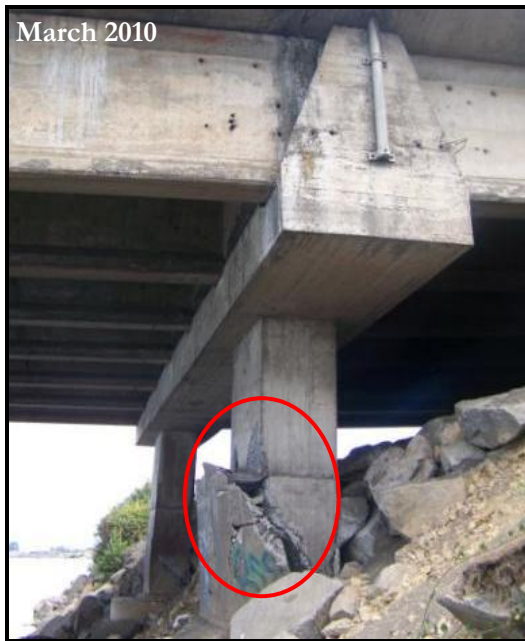
The photo on the left shows Juan Pablo II Bridge fractured column caused by soil liquefaction and lateral spreading along the Bio Bio riverbank. The photo on the right depicts the new bridge girder and columns.
