# M6 SOUTH NAPA EARTHQUAKE

## August 24, 2014

MRP Engineering Summary Report

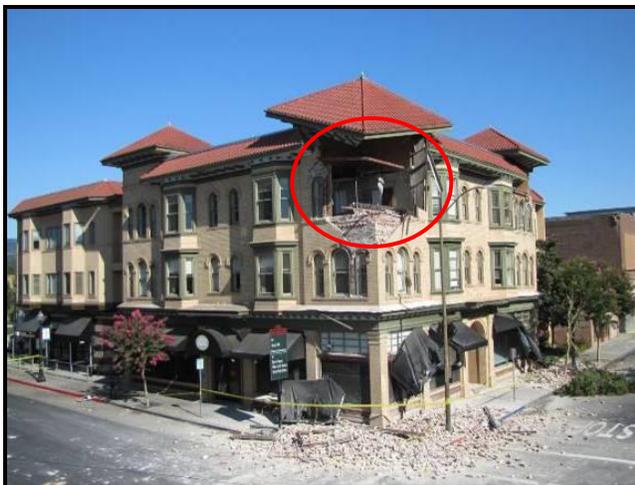
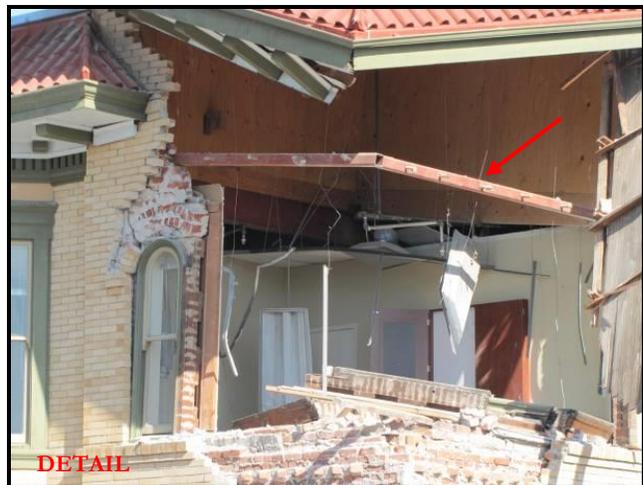
*This three-story structure includes an unreinforced masonry façade, a portion of which collapsed onto the sidewalk below. The close-up photo shows remaining wall anchorage connections below the roofline.*

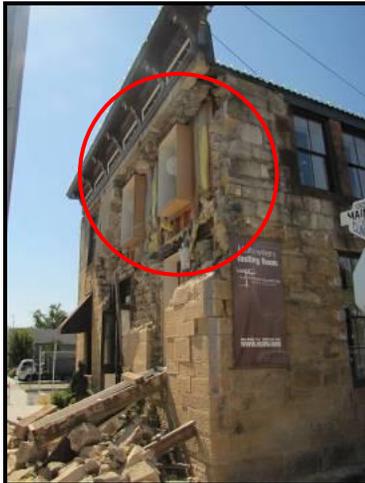
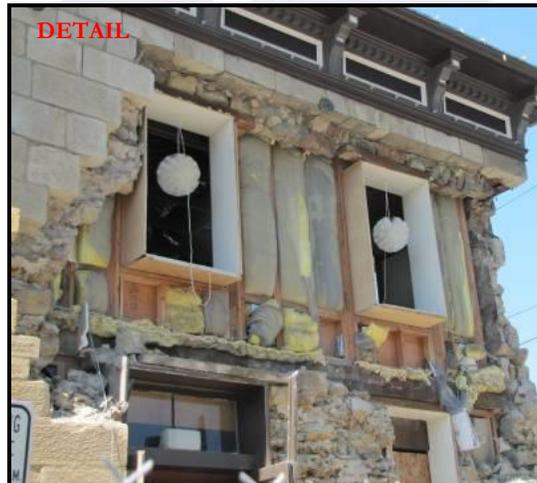
*Damaged 1875-vintage stone masonry building in Napa.  
Note wall anchorage (through bolts with steel plates) in the close-up photo*

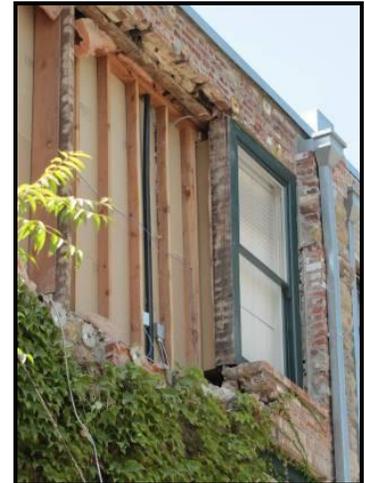
*Masonry wall failure in a building retrofitted with wall anchors at roof and floor levels.*

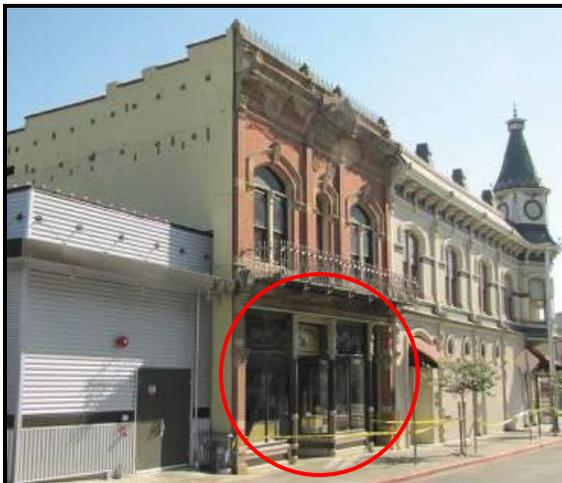
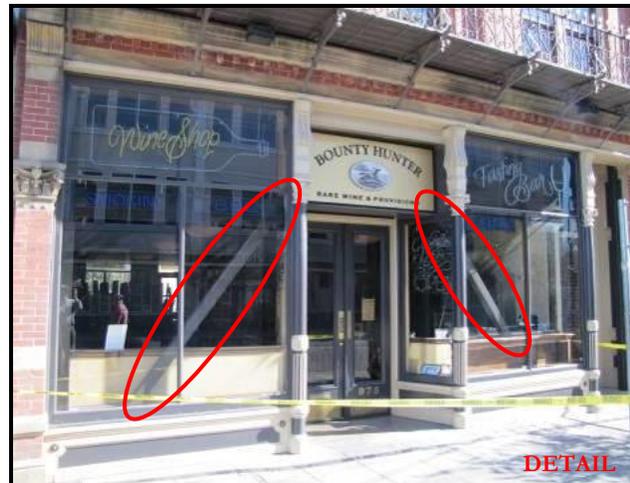
*Retrofitted URM building that survived the earthquake. Upgrades included wall anchors and a steel braced frame at storefront.*

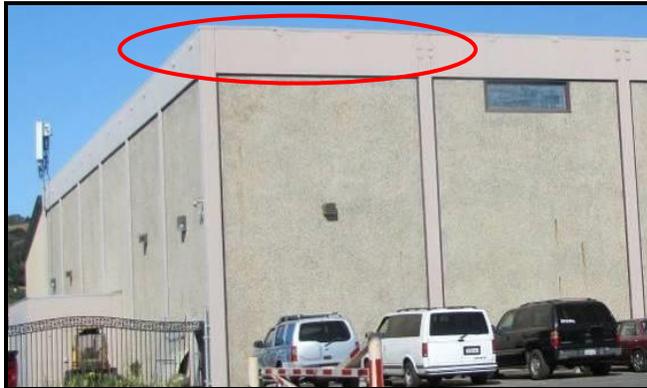
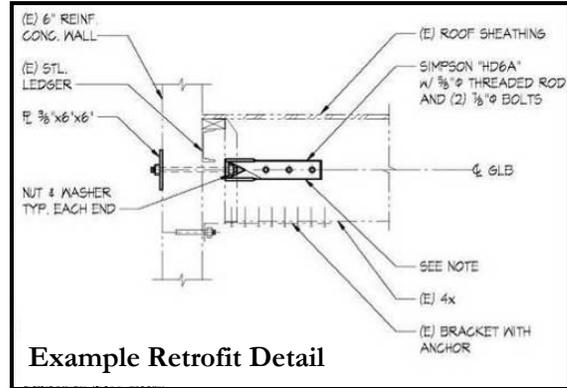
*Proactive upgrades of reinforced concrete tilt-up structures can be effective in preventing roof and wall separation. This building in Napa that survived the earthquakes was retrofitted with wall-to-roof thru-bolt connections.*

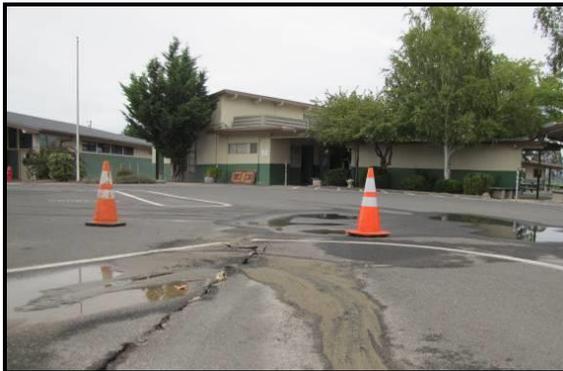
*Ground rupture in an elementary school parking lot south of Napa resulted in fracture of underground water piping.*

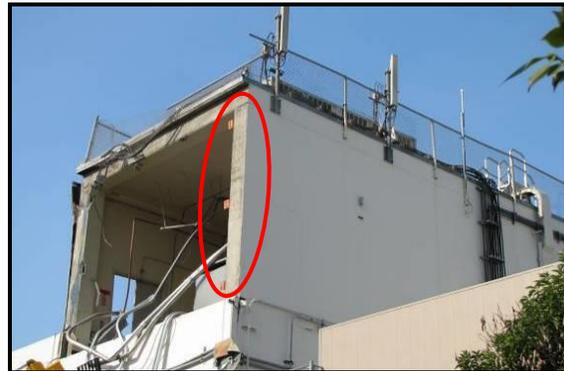
*Precast concrete wall panel connections failure at a local telecom hub damaged HVAC system at this critical facility.*

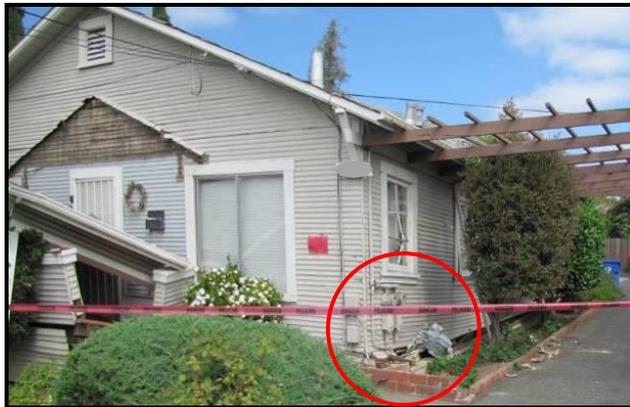
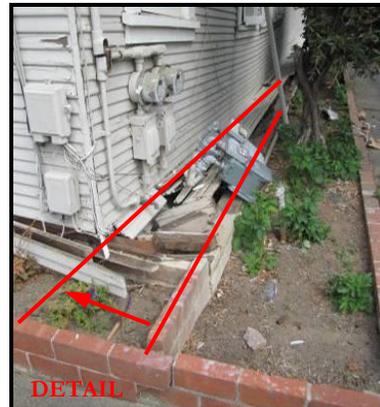
*Residential wood-framed structures that predate modern seismic design consideration can shift from their foundations when short wood-framed walls are present surrounding the crawl space below the main floor. These common failures can lead to a fire-following-earthquake hazard from severed natural gas piping and nearby electrical components. Correcting this condition involves installation of plywood sheathing with floor and foundation connections.*
