ENGINEERING-BASED EARTHQUAKE RISK MANAGEMENT

MRP Engineering Newsletter

February 2012

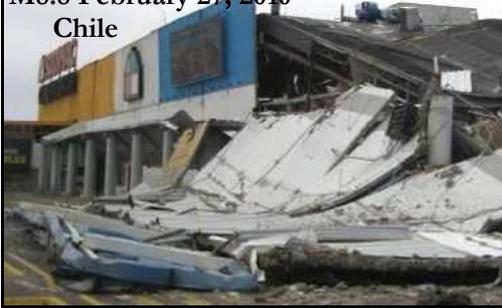
**M8.8 February 27, 2010
Chile**

Collapsed concrete tilt-up wall panels due to weak wall-to-roof connections

- Subduction-type earthquake resulting in over three minutes of strong ground shaking, which affected modern construction at distant locations
- Coastal communities, infrastructure, and industries affected by tsunami inundation, elevation changes, and soil liquefaction
- Relatively modern seismic design practices on par with 1990s American standards, but some modern structures and contents damaged (including high-rises)
- **Updates to reinforced concrete construction practices are necessary and under consideration.**

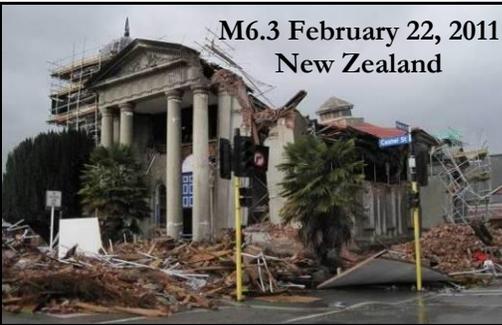
**M6.3 February 22, 2011
New Zealand**

Collapsed unreinforced masonry structure in Christchurch

- Shallow-depth earthquake on an unmapped fault in area long considered a “moderate” hazard
- Very high horizontal and vertical accelerations
- Extensive soil liquefaction affecting utilities and building foundations
- Severe damage to some relatively modern multi-story buildings as well as historical masonry structures
- **Major reconstruction planning is underway involving new, existing, and historic buildings.**

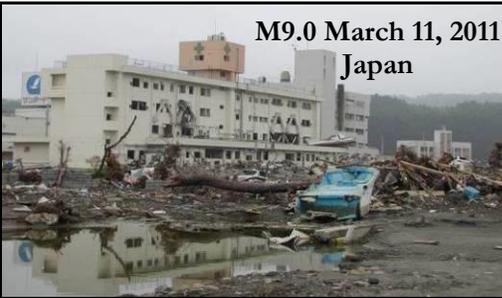
**M9.0 March 11, 2011
Japan**

Seismically retrofitted hospital in Minamisanriku survived as a vertical (tsunami) evacuation shelter

- Largest subduction-zone event and tsunami in Japan
- Culture of earthquake preparedness and research with modern seismic design and construction practices
- Tsunami destruction of low-lying coastal communities, lifelines, and industry in the northeast (Tohoku) region, with massive debris and rebuilding required; waterfront facilities in Tokyo (400 km away) impacted
- National power resources (nuclear energy) and international commerce affected
- **Better disaster preparedness and re-evaluation of design and construction standards required.**

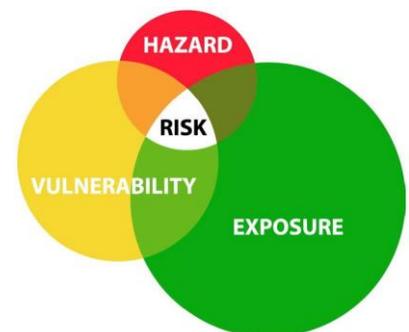
Earthquake risk represents a combination of hazard, vulnerability, and exposure. **Seismic hazard** is the potential for strong ground shaking or other earthquake-related hazards such as settlement, landsliding, ground rupture, or tsunami at a site of interest. **Vulnerability** represents the potential for damage given a facility’s construction, configuration, condition, structural elements, and connections. **Exposure** is a measure of the financial impact should damage occur. Together, vulnerability and exposure describe the consequences of the seismic hazards.

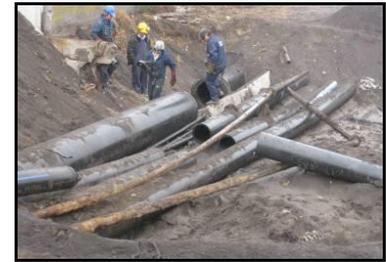
Site-specific hazards: Soil conditions at a site of interest and type of foundations can have a significant impact on the earthquake response. For example, sites consisting of saturated alluvial (sandy) deposits may experience soil liquefaction, resulting in loss of bearing strength and excessive settlements and leading to significant damage to structures or shallow-bedded utilities (see adjacent photo).

Soil impacts: repairs of piping damaged by soil liquefaction

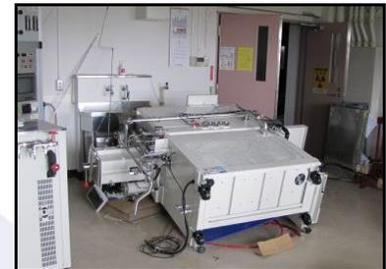
Equipment and contents: Damage to inadequately restrained equipment and contents can dominate earthquake losses and re-occupancy (see adjacent photo). A walk-through of representative equipment and nonstructural elements, when performed by experienced earthquake engineers, can provide a reasonable assessment of potential equipment risks.

Equipment impacts: toppled unrestrained lab workstations
