## MRP ENGINEERING IN HAITI AFTER THE 2010 M7.0 EARTHQUAKE

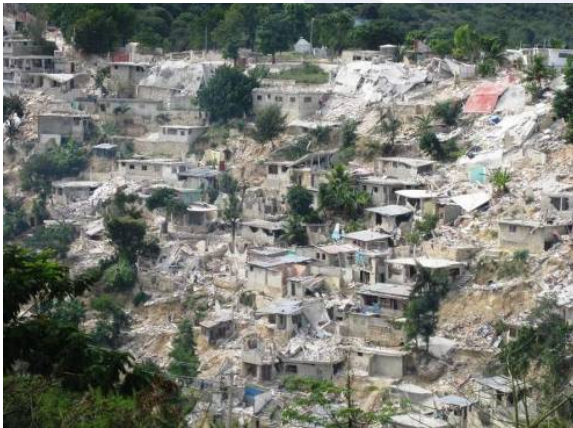
Canapé Vert Neighborhood

Poorly constructed houses were destroyed by strong ground shaking and slope failures.

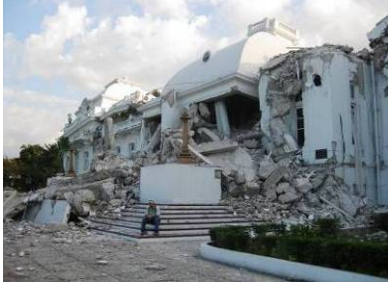
Haitian National Palace

The two-story structure, built between 1914 and 1921, partially collapsed during the event.

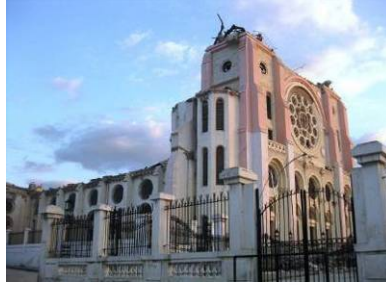
Port-au-Prince Cathedral

The roof and the towers flanking the main entrance collapsed. The lower parts of the walls remain standing. Nunciature and archdiocese offices also collapsed.

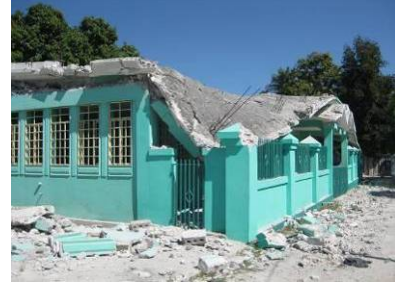
Hospital, Santo (north of airport)

This newly constructed two-story hospital was nearly ready for occupancy when the earthquake struck. The reinforced concrete frame structure experienced collapse at the second level.

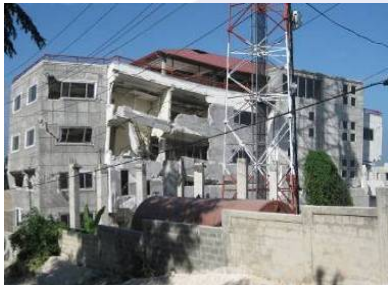
Hai Tel Switch Building, Canapé Vert

The overall mobile telephone network survived but was strained by the phone call volume. This office and switch building suffered major structural damage. The switch equipment reportedly continued to function.

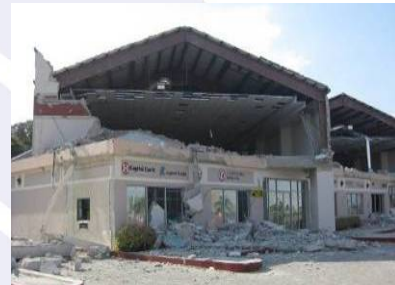
Port-au-Prince (airport area)

Collapsed masonry façade at a commercial complex near the U.S. Embassy. Light steel-framed steel section in the background survived the earthquake.
