# M9.0 GREAT EAST JAPAN EARTHQUAKE & TSUNAMI

## March 11, 2011

MRP Engineering Summary Report

August 2011

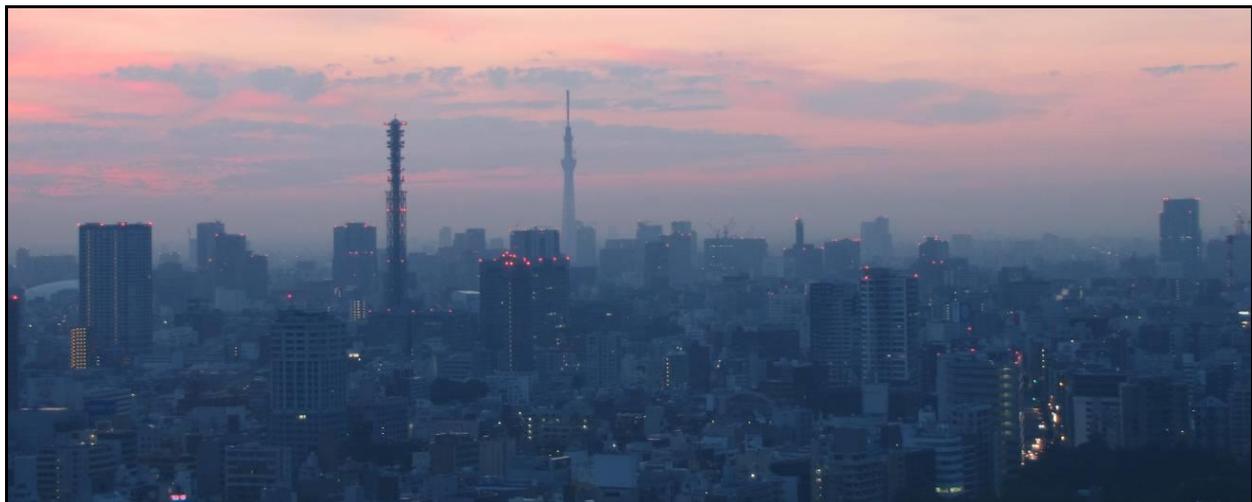
*Sunrise above Tokyo skyline with reduced building lights in July 2011. Electrical power supply restrictions led to reductions in nonessential lighting. Many businesses adjusted operations or installed additional backup generators to cope in the aftermath.*
