M8.8 MAULE EARTHQUAKE

February 27, 2010

MRP Engineering Summary Report

March 2011

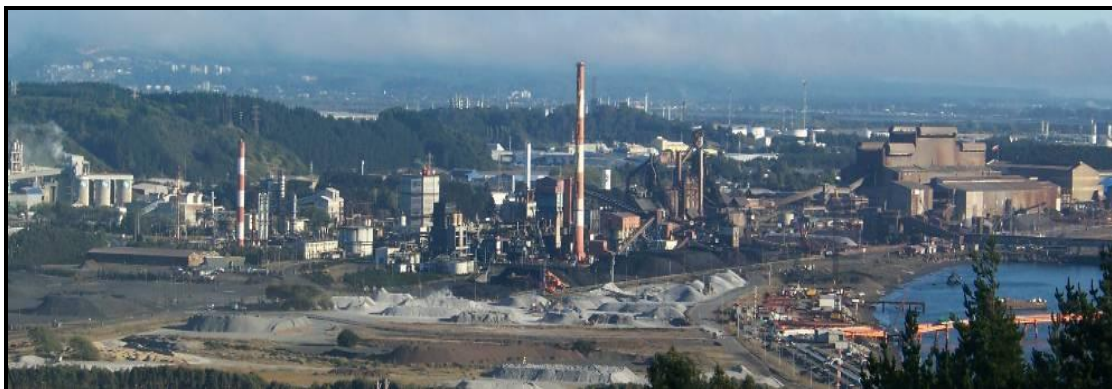
Panoramic view of heavy industry in Talcahuano.

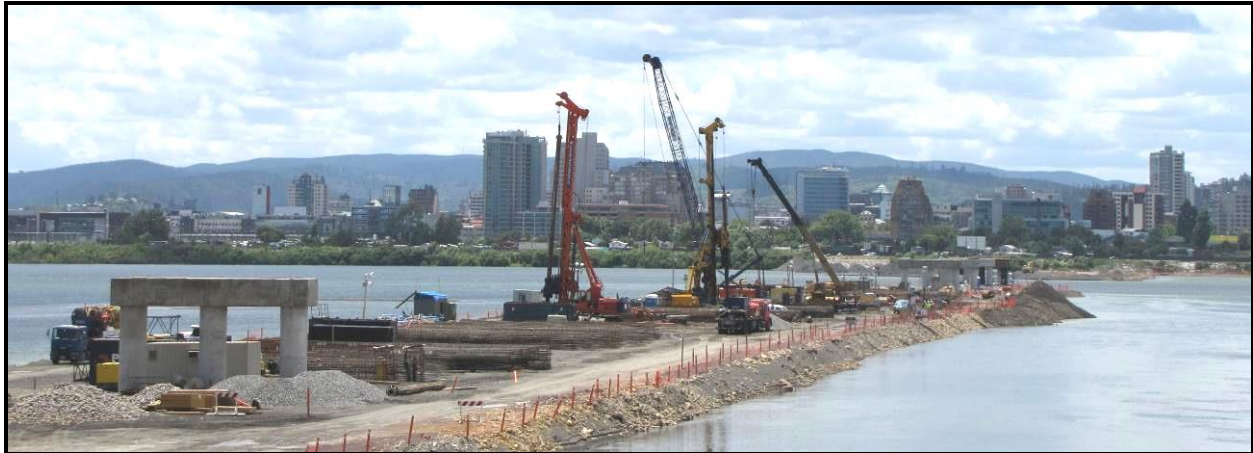
December 2010: Construction is in progress on a new highway bridge over the Bío Bío River in Concepción. This crossing will replace a bridge damaged by the earthquake. The city skyline (background) includes a number of vacant residential towers.

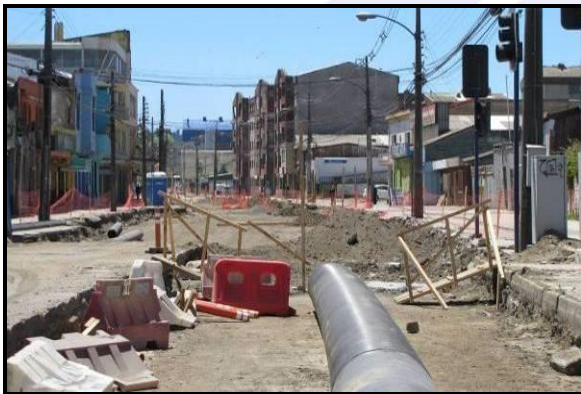
Street and utility reconstruction in Talcahuano city center is evident throughout the low-lying areas of this community.

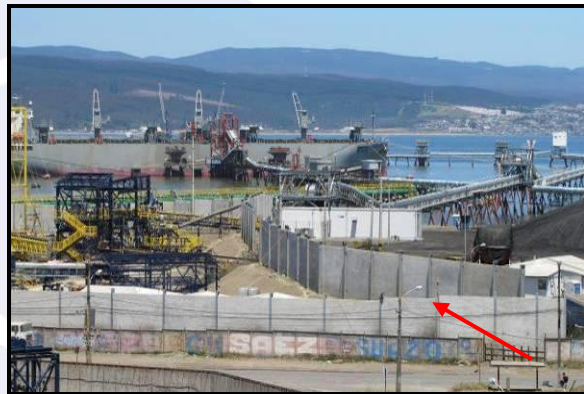
Low-lying areas of Port of Coronel (south of Concepción) are surrounded by newly constructed flood walls.

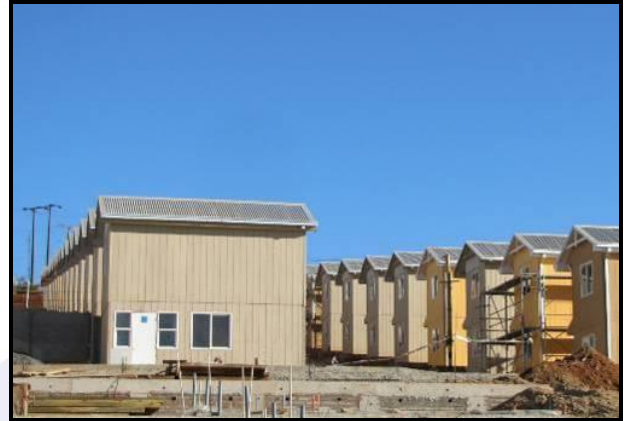
Fast-track community of wood-framed housing for residents displaced by tsunamis

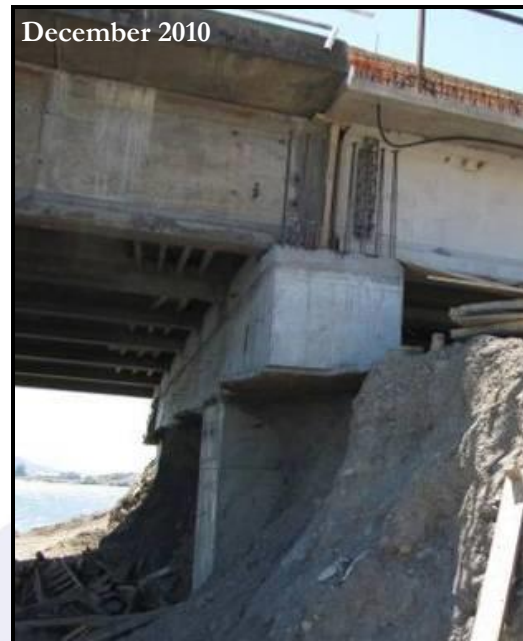
The photo on the left shows Juan Pablo II Bridge fractured column caused by soil liquefaction and lateral spreading along the Bio Bio riverbank. The photo on the right depicts the new bridge girder and columns.
