MRP ENGINEERING IN HAITI AFTER THE 2010 M7.0 EARTHQUAKE

On January 12, 2010, a devastating M7.0 earthquake struck near Port-au-Prince, Haiti. The earthquake was the result of strike-slip motion along the Enriquillo-Plantain Garden fault system, which is near the boundary of the Caribbean and North American plates. Over 50 aftershocks of magnitude 4.5 or greater followed the main event, with a M5.8 aftershock occurring on January 20, 2010. According to current estimates, there were over 150,000 casualties and over one million made homeless.

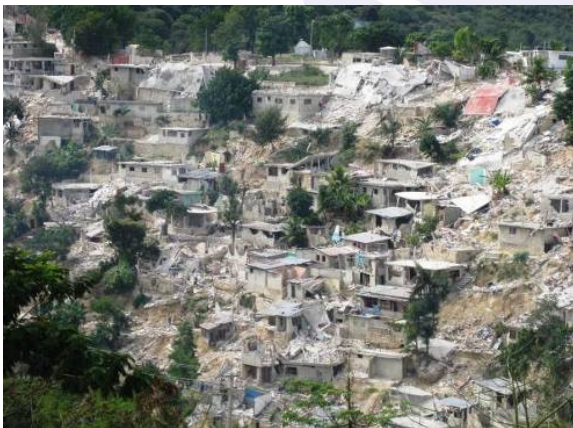
Canapé Vert Neighborhood

Poorly constructed houses were destroyed by strong ground shaking and slope failures.

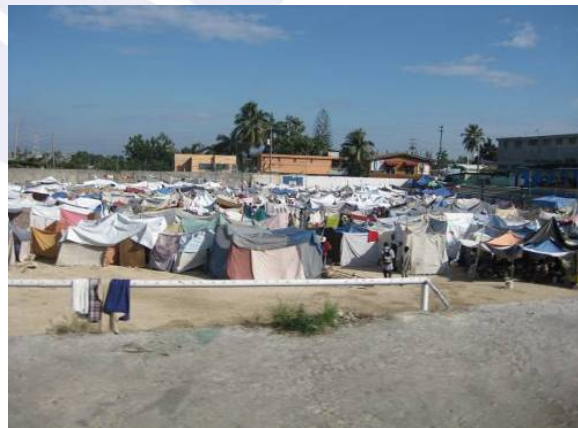
Survivor Camps

Fearing aftershocks, most of the residents camp on any available open space, even if their homes survived.

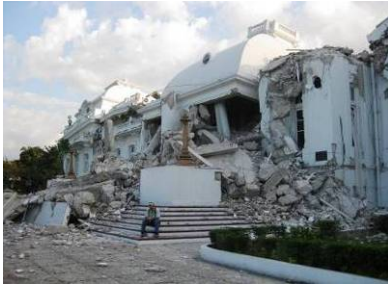
Haitian National Palace

The two-story structure, built between 1914 and 1921, partially collapsed during the event.

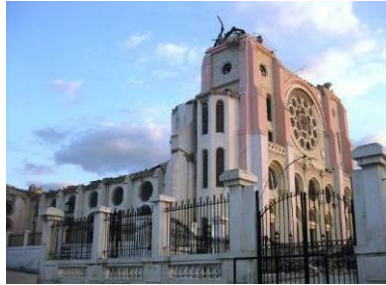
Port-au-Prince Cathedral

The roof and the towers flanking the main entrance collapsed. The lower parts of the walls remain standing. Nunciature and archdiocese offices also collapsed.

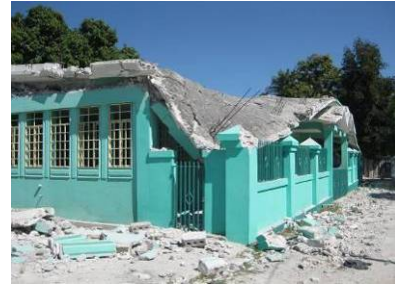
Hospital, Santo (north of airport)

This newly constructed two-story hospital was nearly ready for occupancy when the earthquake struck. The reinforced concrete frame structure experienced collapse at the second level.

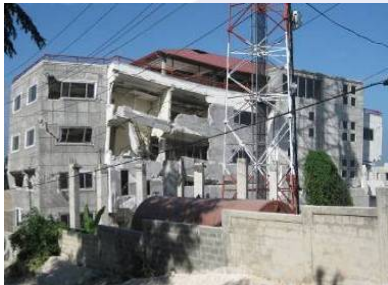
Hai Tel Switch Building, Canapé Vert

The overall mobile telephone network survived but was strained by the phone call volume. This office and switch building suffered major structural damage. The switch equipment reportedly continued to function.

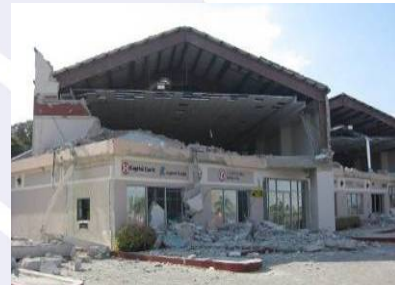
Port-au-Prince (airport area)

Collapsed masonry façade at a commercial complex near the U.S. Embassy. Light steel-framed steel section in the background survived the earthquake.
